**PRELIMINARY
GEOTECHNICAL REPORT**

**DANVILLE HOTEL SITE
411 HARTZ AVENUE
DANVILLE, CALIFORNIA**

**Prepared by:
ENGEO**

**July 13, 2010
Project No. 9004.000.000**

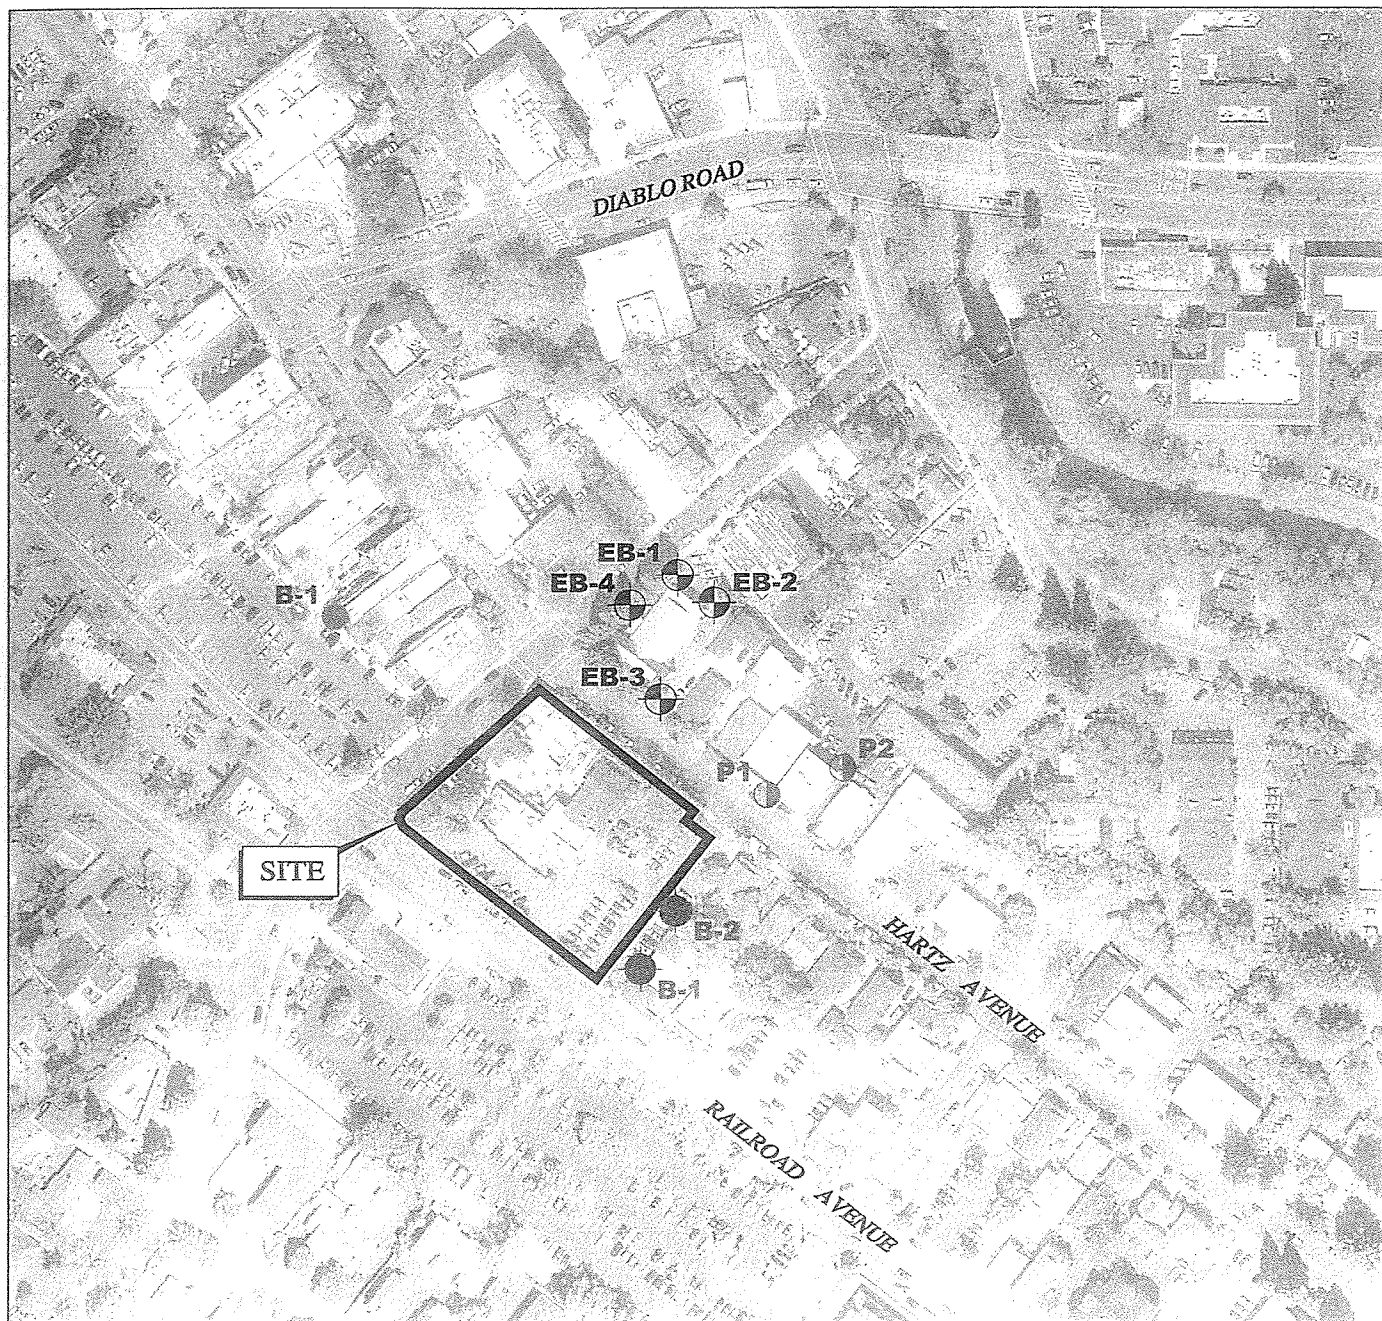
2

EXPLANATION

- EB-4 APPROXIMATE LOCATION OF BORING (CEG, 2009)
- B-2 APPROXIMATE LOCATION OF BORING (ENGEO, 1987)
- P2 APPROXIMATE LOCATION OF PROBE (ENGEO, 1998)
- B-1 APPROXIMATE LOCATION OF PROBE (ENGEO, 1996)

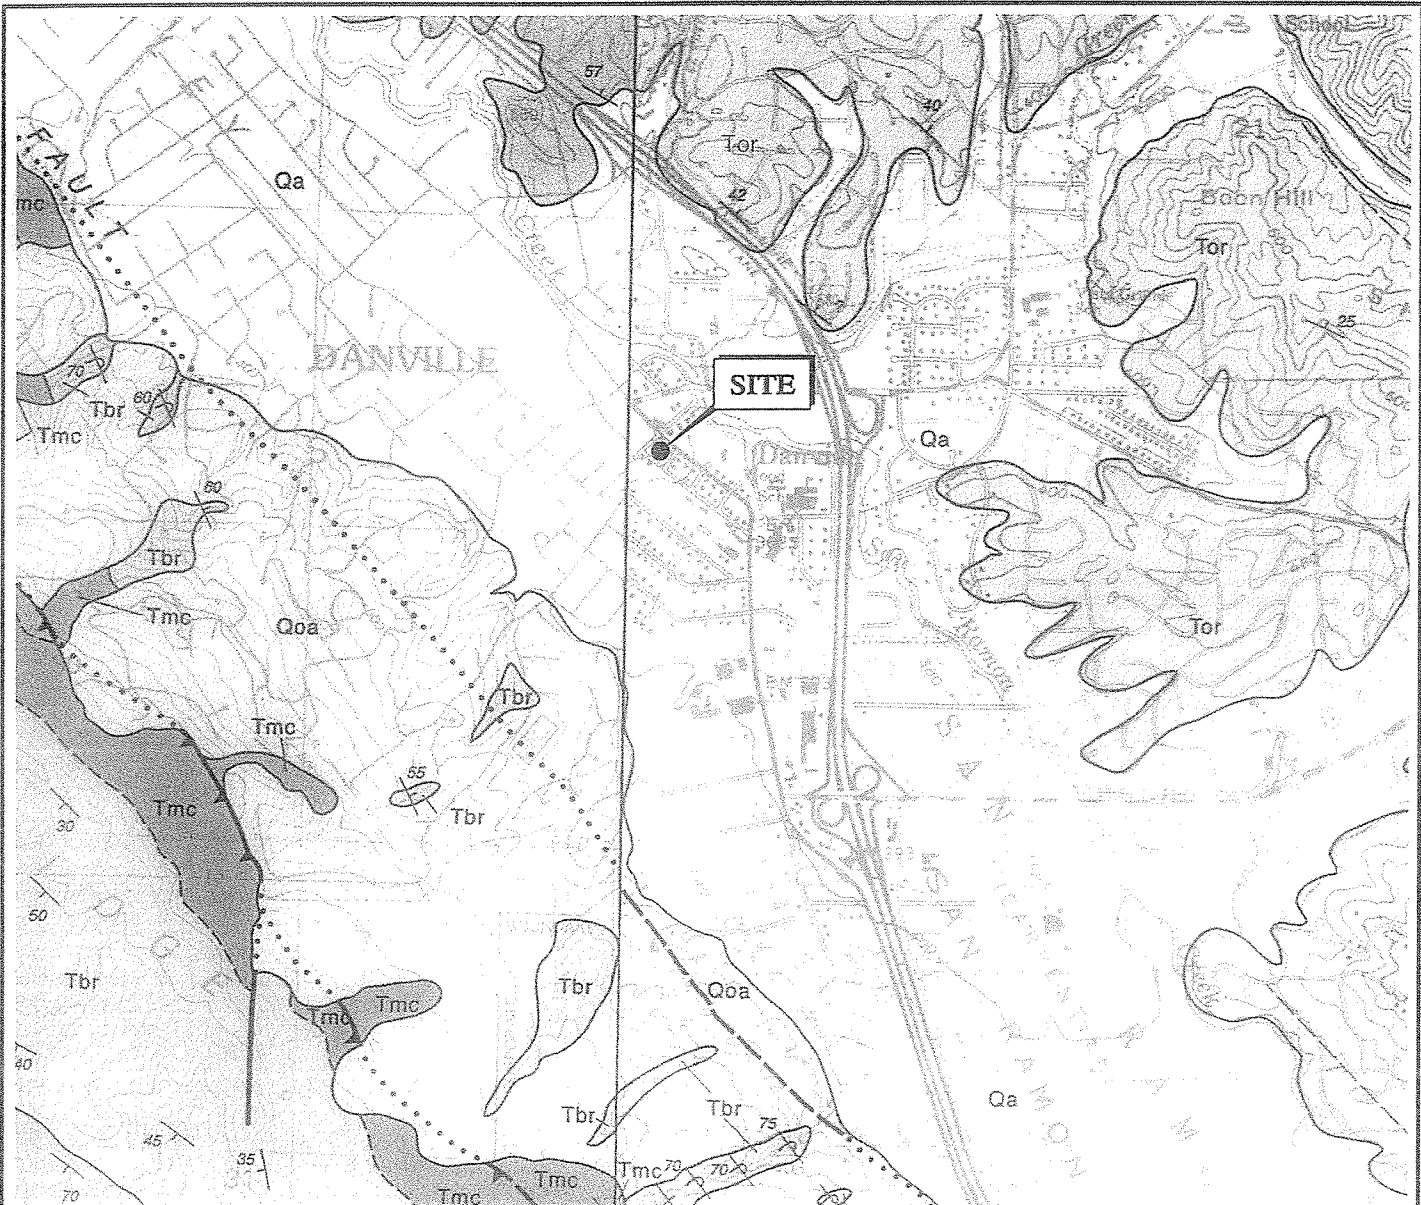
3

EXPLANATION

--- BEDROCK CONTACT-DASHED WHERE GRADATIONAL OR APPROXIMATELY LOCATED

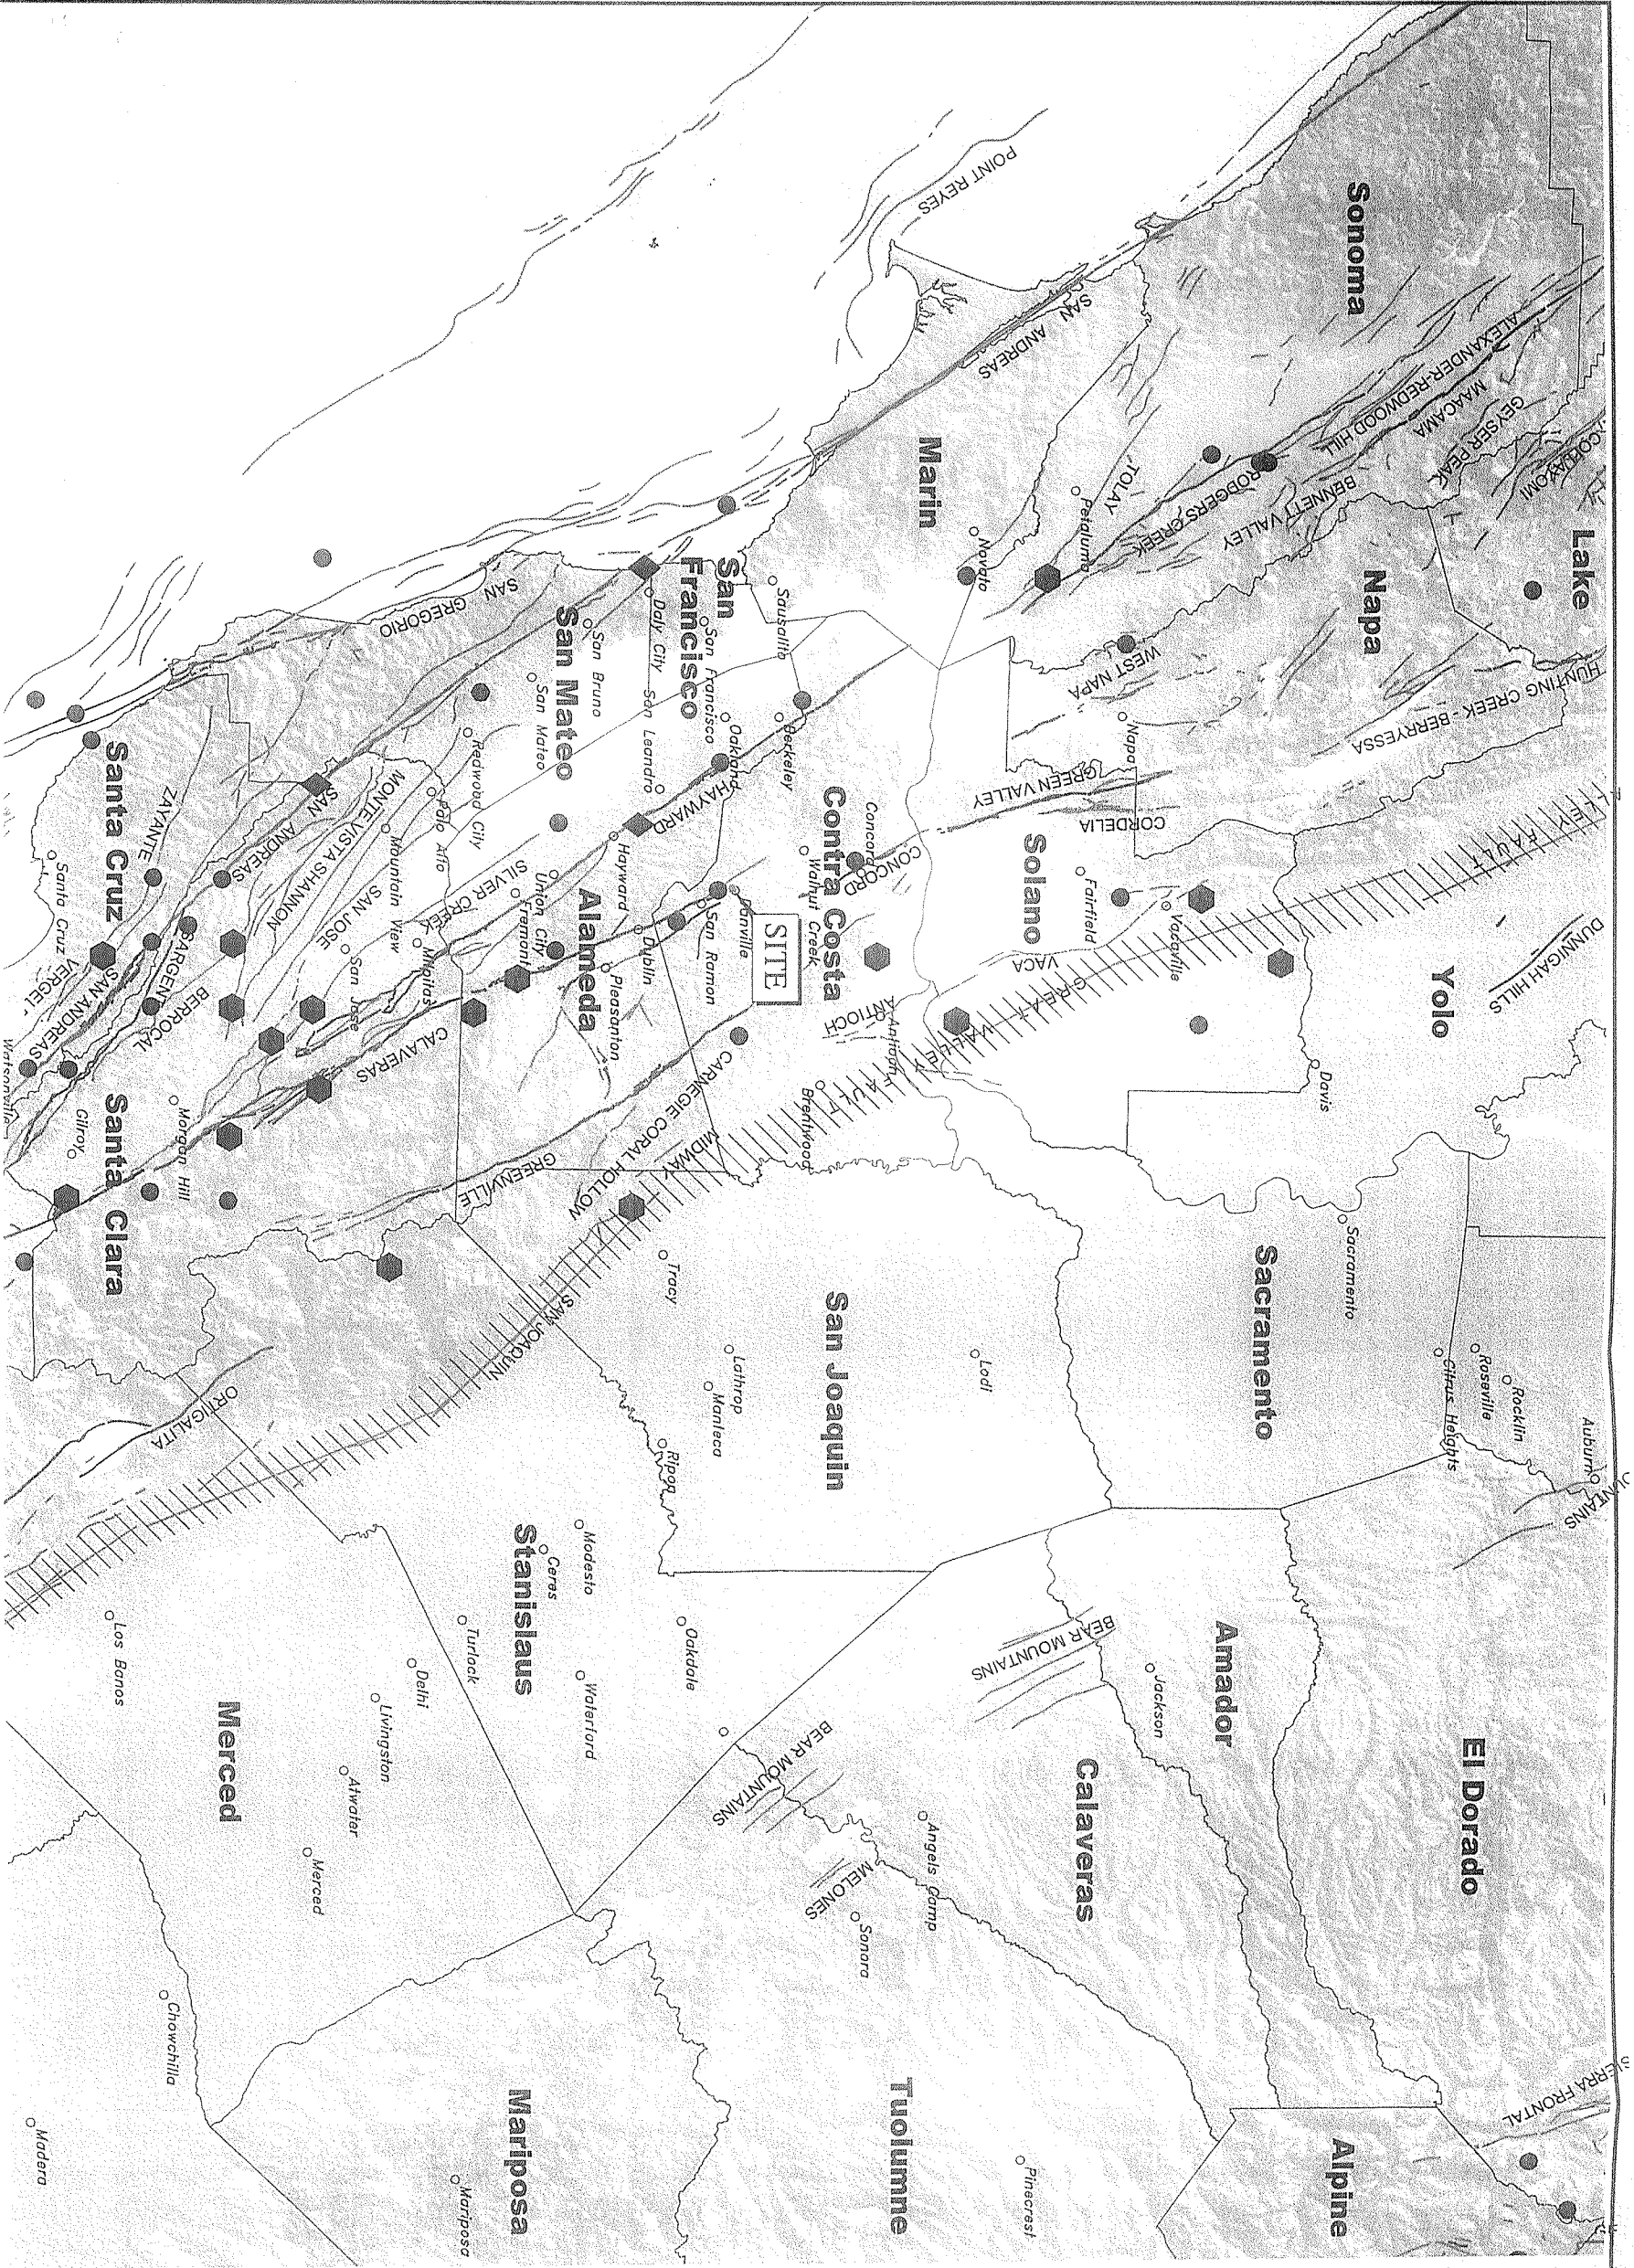
Figure 4: Regional Faulting and Seismicity Map

BASE MAP SOURCE:
 U.S.G.S. 1-ARC SECOND S.R.T.M. DATABASE
 U.S.G.S. QUATERNARY FAULT DATABASE, MARCH, 2006
 U.S.G.S. HISTORIC EARTHQUAKE DATABASE (1800-2000)

No known active¹ faults cross the property and the site is not located within an Alquist-Priolo Earthquake Fault Zone; however, large maximum Moment magnitude² (M_w) earthquakes have historically occurred in the Bay Area and many earthquakes of low magnitude occur every year. The nearest faults zoned as active by the State of California Geological Survey are the Northern Calaveras fault located approximately ½ mile to the southwest, the Concord fault located approximately 4.8 miles to the north, and the Hayward fault located approximately 9.3 miles to the southwest. Figure 4 shows the location of these faults and other active and potentially active faults of the region. In addition, the 2007 Working Group on California Earthquake Probabilities (WGEP) estimates there is a 63 percent probability that a magnitude $M_w = 6.7$ or greater earthquake will occur on the known active fault systems within the Bay Area. The WGEP estimates a 7 percent probability of the same magnitude event occurring on the Calaveras fault within 30 years of their study (2007 – 2037) and the estimate for the Hayward-Rogers Creek fault is 31 percent.
